RE: PRE-RENOVATION ASBESTOS SURVEY
BASEMENT CEILING
220 5TH AVENUE
NEW YORK, NEW YORK 10001

# TARGETED PRE-RENOVATION ASBESTOS SURVEY

220 5TH AVENUE BASEMENT CEILING NEW YORK, NEW YORK 10001

Job No. STLL1702

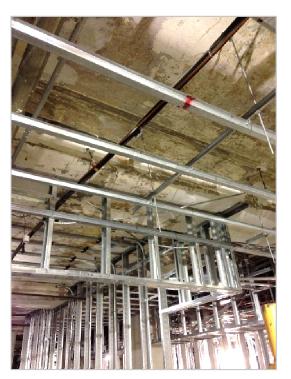
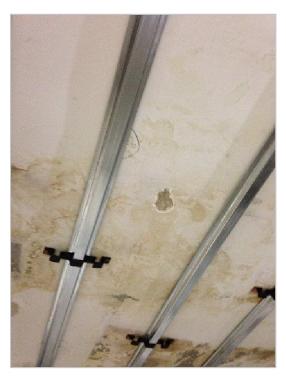
**Photographs 1 - 2.** Plaster Top Coat (non-ACM) and Bottom Coat (non-ACM) Above Drop Ceiling in Various Locations

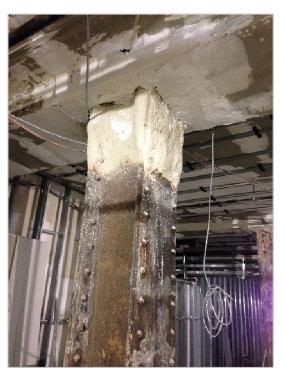
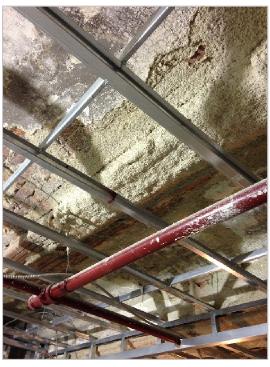
Samples of spray-applied fireproofing above the ceiling were noted to contain vermiculite which, by New York State regulations effective October 31, 2014, require further testing by NYS ELAP Method 198.8. Because the additional testing requires a large volume of material, additional samples of the spray-applied fireproofing were collected by Pennoni's Mr. Joseph Celentano (NYC DEP Asbestos Investigator Certificate 136735) on August 16, 2017 and were transported to EMSL in Cinnaminson, New Jersey for analysis. Analytical results indicate that the spray-applied fireproofing is not asbestos-containing (see Appendix C – Laboratory Analytical Certificates).

**Photographs 3 - 4.** Spray-Applied Fireproofing (non-ACM) Above Drop Ceiling on Beams, Columns, and Wall in North Section

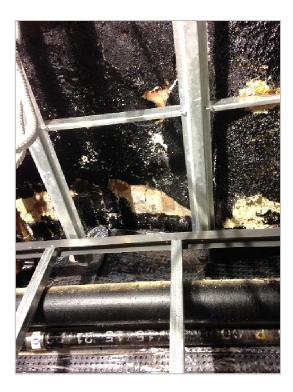
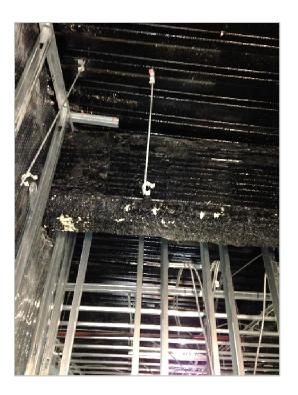
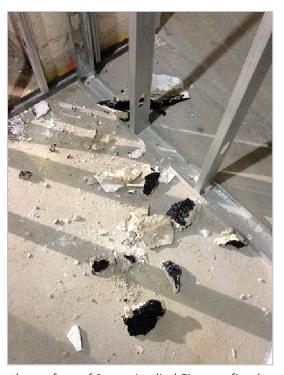
Photographs 5 - 8. Black Waterproofing (non-ACM) generally on the surface of Spray-Applied Fireproofing (non-ACM)

Above Drop Ceiling on Beams, Columns, and Wall in North Section, and some debris on floor

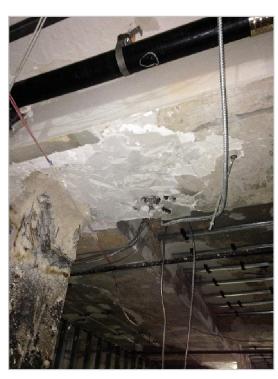
**Photograph 9.** White Plaster Patching (non-ACM) Above Drop Ceiling in South Section

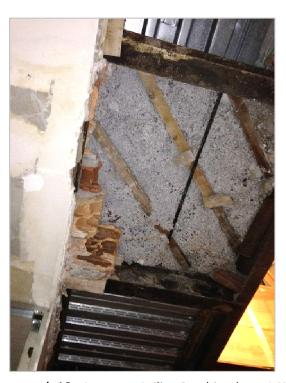
**Photograph 10.** Concrete Ceiling Patching (non-ACM) *Above Drop Ceiling Throughout*
